FINAL INSPECTION REPORT

LEO ROY PARKING GARAGE

100 MARKET STREET

University of
Massachusetts
Lowell

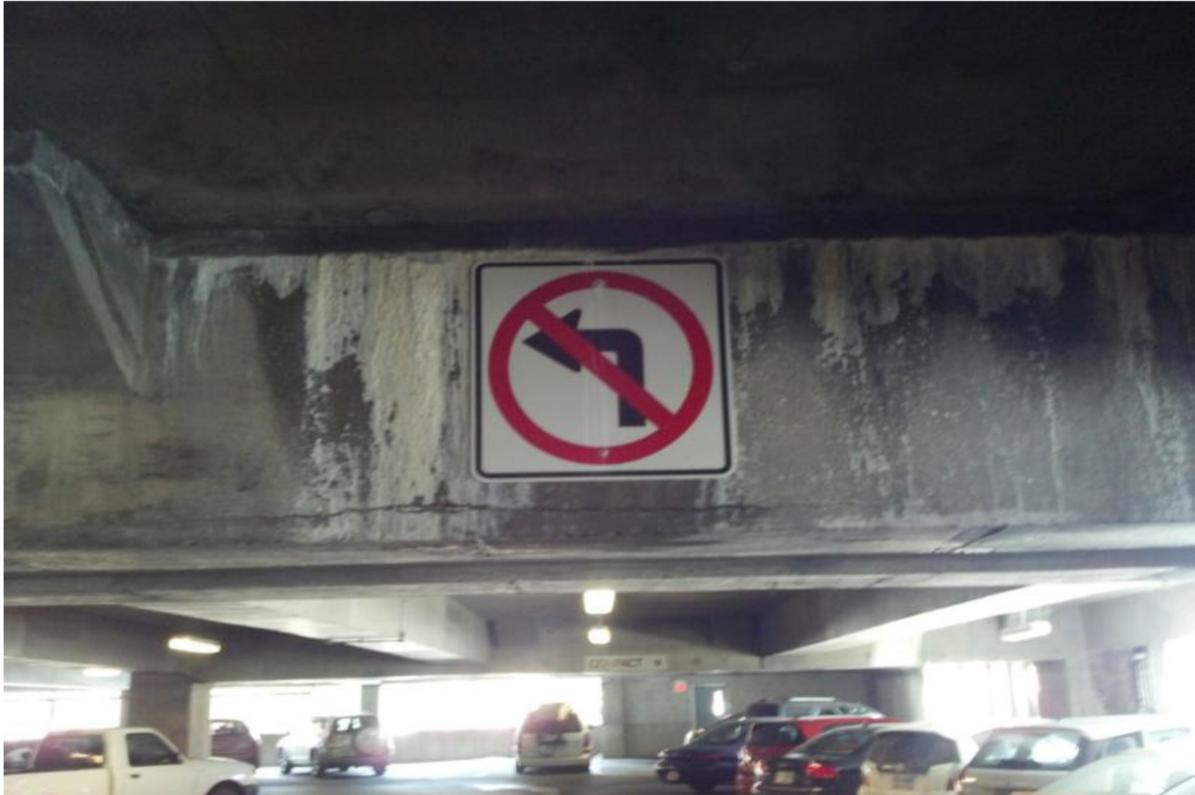
Photo 1: Efflorescence and leaching at cross beam K on 1st floor, typical

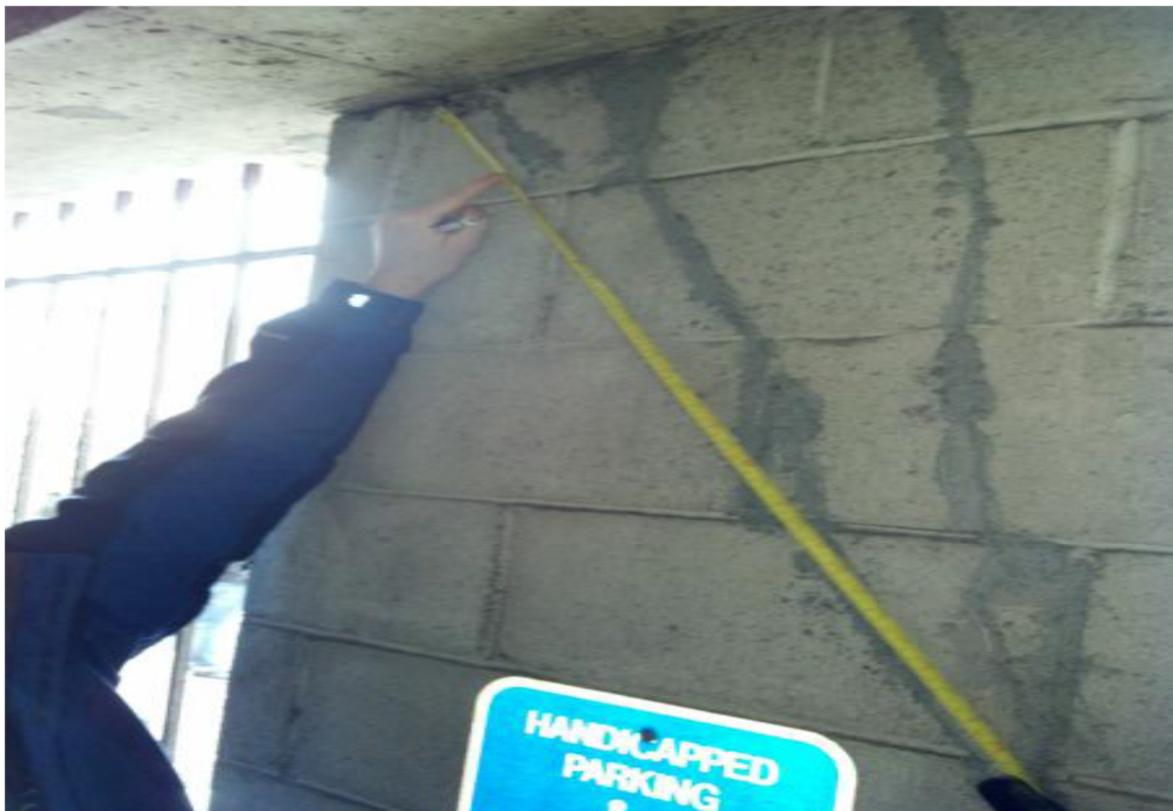
Photo 2: 42 inch by 1/2" sealed crack in concrete masonry block adjacent to 1st floor entrance

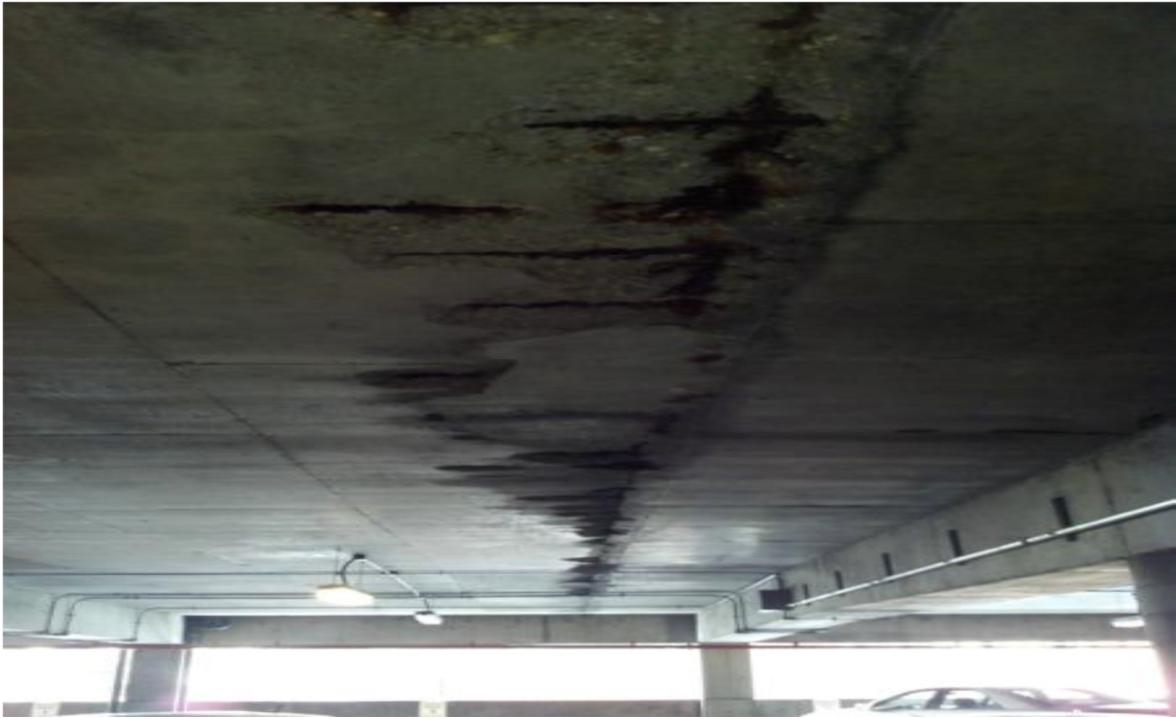
The third and final location we inspected was the ceiling between beams 7 and 8 on the third floor. It is important to note that similar conditions were found at this location on all floors and they may have similar results. We first used the rebound hammer as seen in Photo #21 to determine the condition of the concrete in an area adjacent to a large area of spalling and exposed rebar. The results indicate a significant variation between control readings and experimental readings. This difference was greater than at any of the other two locations and indicates an ongoing problem of concrete deterioration. The proximity of visually spalled concrete suggests the possibility of future spalls in the immediate area. The rebar locator was also used at this location (see photo #22). The experimental reading of 1.2 versus the control of 2 suggests that there is a possible lack of cover or corroded rebar in the area adjacent to the spalls. This indicates that there is a possibility of further spalling of concrete and corrosion of rebar and this area should be monitored for future deterioration. Possible causes of this

condition appear to be construction related since a similar condition occurs on all floors in a similar location.

***Photo 3: Failed patch with spalling and exposed rebar, full width of structure
Between beams 7 and 8 on first floor, typical all floors.***

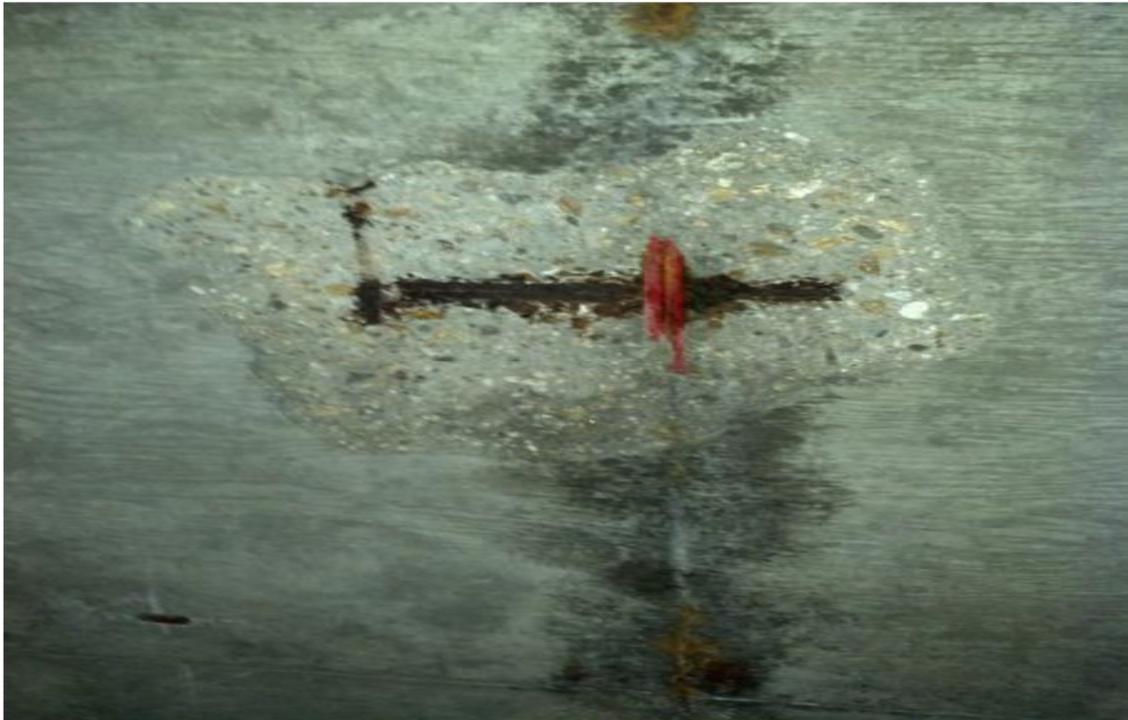
Photo 4: 10" x 10" spall with exposed rebar and electrical cable in ceiling on 1st floor between columns R-8 and R-9.

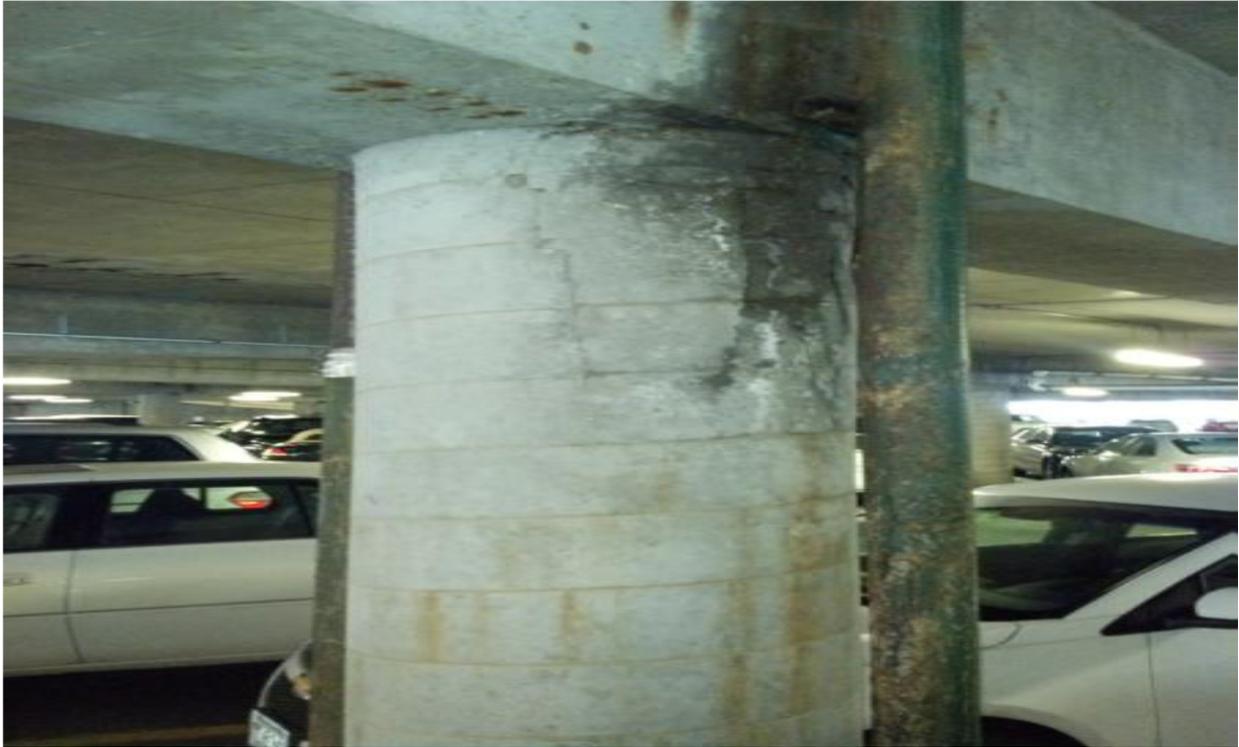
Photo 5: Deterioration of column R-7 adjacent to leaking drain pipe on 1st floor.

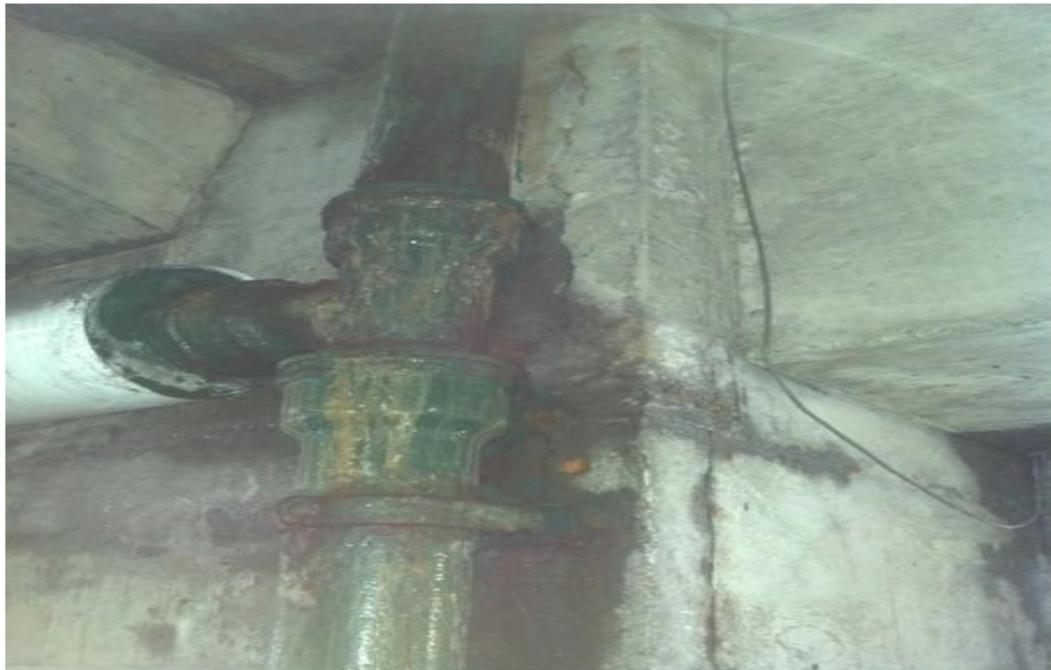
Photo 6: Cracking of concrete adjacent to leaking drain pipe at column G-3 on 1st floor

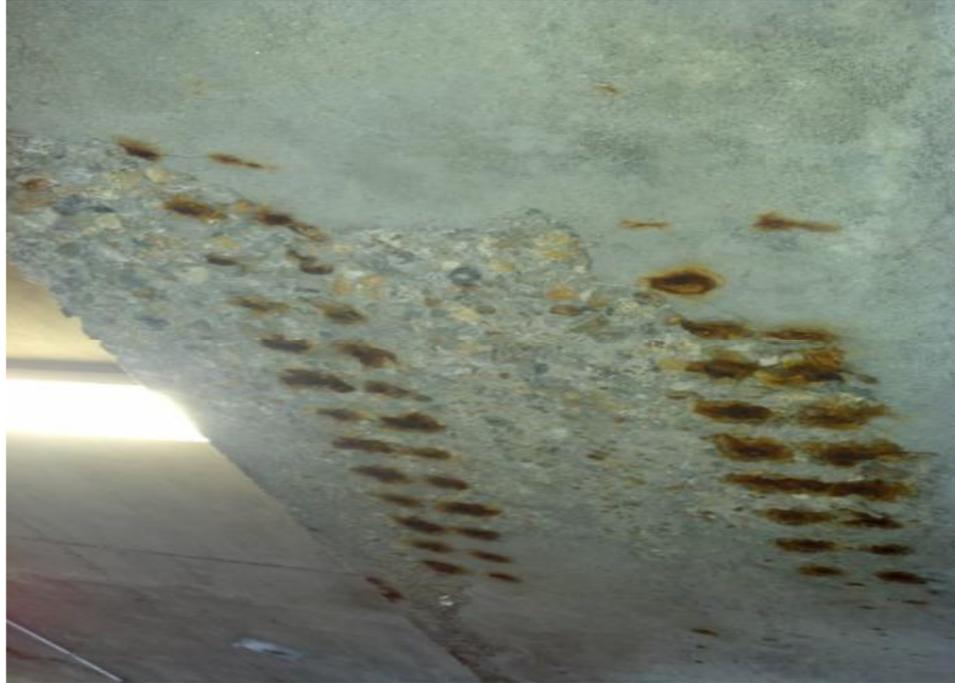
We observed similar deterioration at Beam line G near the entrance. The rebound hammer showed an even larger difference between control value and experimental reading. This indicates a severe deterioration in the concrete, confirming our visual observation of severe scaling. We also used the rebar locator on this beam in order to evaluate any possible or future corrosion of rebar. Although there was no visible spalling or exposed rebar at this location, the average rebar locator magnetic reading of .9 versus the control reading of 3 indicate a possible lack of cover. This lack of cover could result in ease of infiltration of chlorides which will cause corrosion of the steel. It is also possible that this low magnetic reading indicates that portions of steel may already be corroded or contaminated with chlorides. If the steel is already deteriorated, the magnetic reading may be affected and give such a result. It is possible that this type of deterioration is a result of poor construction practice such as finishing and curing. It is also possible this deterioration could be due to the beams proximity to the open air entrance, resulting in road salt chloride infiltration.

Photo 7: Severe scaling with exposed reinforcement in cross beam (column line G) between entrance and up ramp on 1st floor.

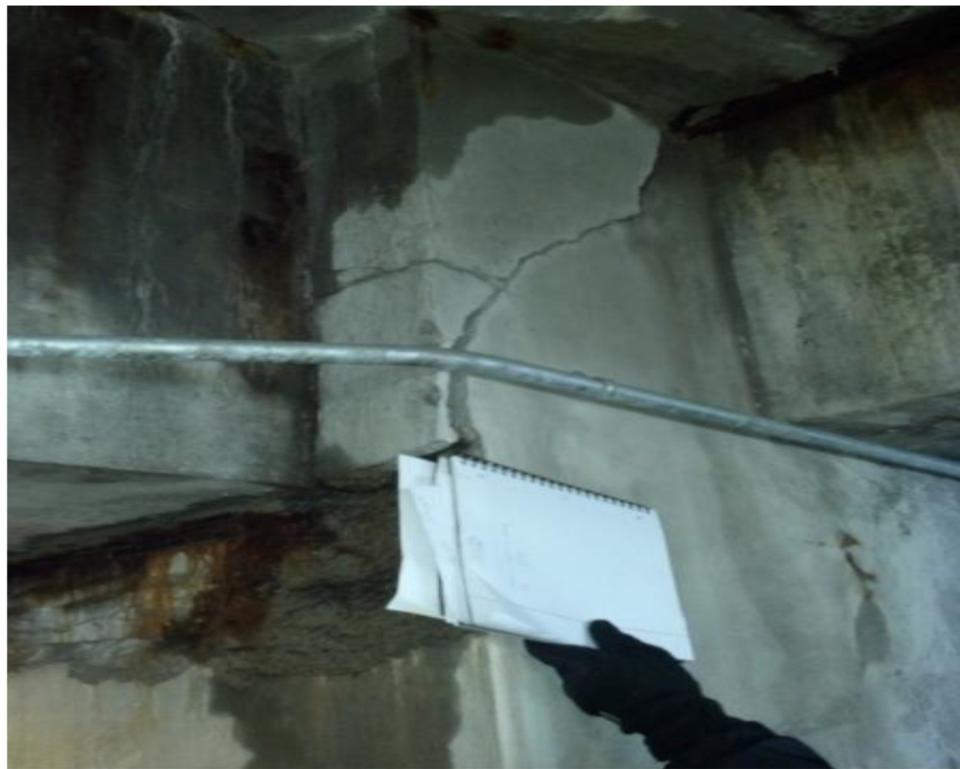
Together with visual observations, the measurements confirm that there is some ongoing deterioration in the concrete within the overall structure. At first floor column E10, it was observed that the average reading for the rebound hammer resulted in about a 3000 psi difference from the control. It should be pointed out that most of the concrete in the structure was designed for 4000 psi compressive strength. In some cases the rebound hammer indicates up to 10,000+ psi existing strength. This reading should be used with caution since it is unlikely the actual strength of the concrete is that much higher than the design strength. Some possible sources of this error may include equipment failure or human errors in calibration, operation, reading of measurements, and conversion to psi using the manufacturer's charts. Although the psi reading itself may not be accurate, we can still make an assessment of the structures condition based on the *relative* difference between the experimental measurement and the control. In the case of the column, there is an approximate 30% loss of concrete strength compared to the control. This loss of strength may be due to corrosion of rebar or chemical (such as chloride) attack. Note that the rebar locator was not used at this location as we felt it would not provide significant information due to the layout and condition of the already large areas of exposed rebar.

Compressive strength test results of column E10 are found to be considerably lower when compared to the compressive test of the other column (control). This may be the reason why this column presents excessive crack openings. This fact may be a strong argument to contact a structural engineer to conduct a structural analysis to verify whether the column is in the imminence of failure or not.

Photo 8: 1/2" by full beam height crack with spalling of beam support at column E-10, 1st floor.

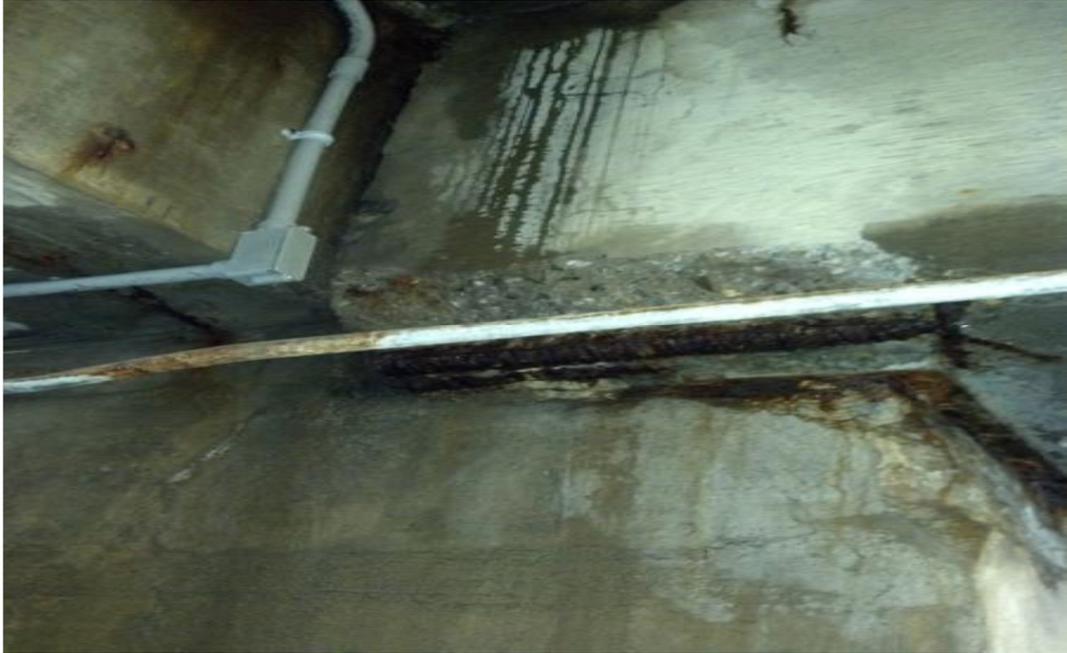
Photo 9: Spalling with exposed rebar at beam support at column E-10, 1st floor.

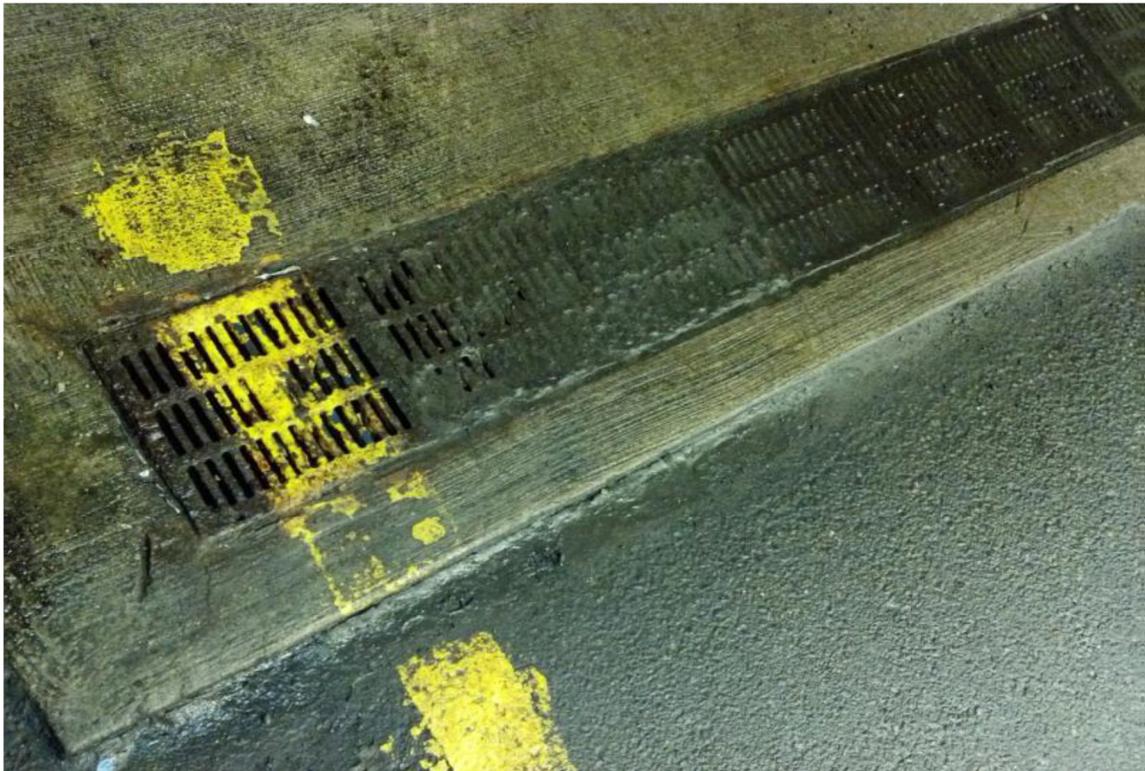
Photo 10: Clogged drain at bottom of 1st floor up ramp. Typical all drains on all floors

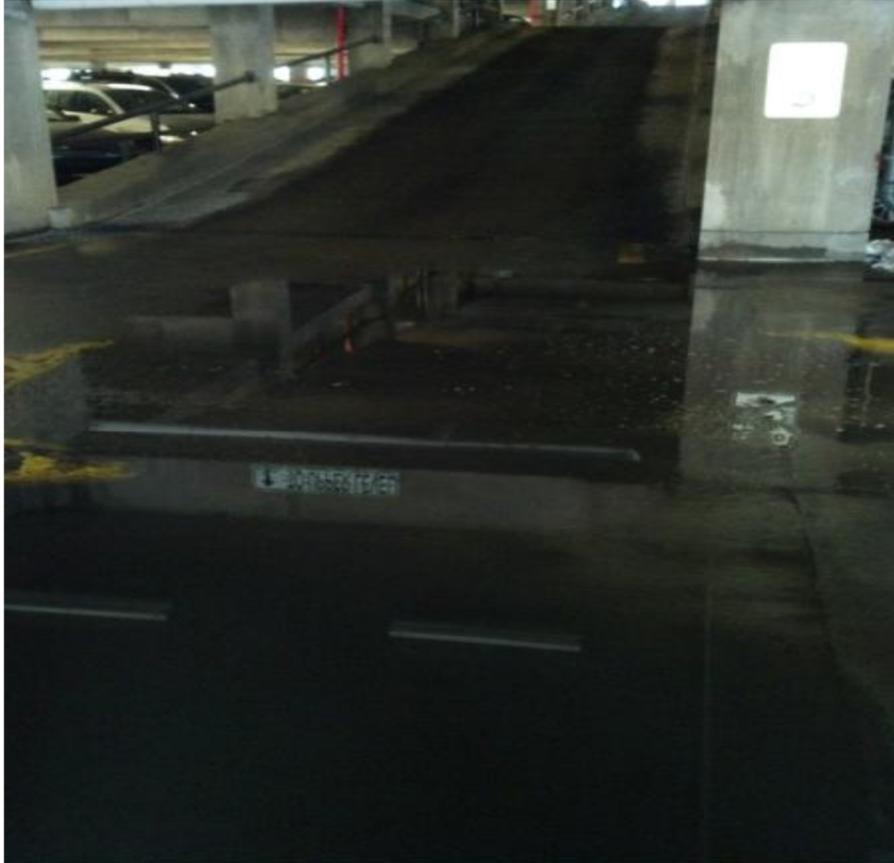
Photo 11: Standing puddle at bottom of down ramp on 2nd floor

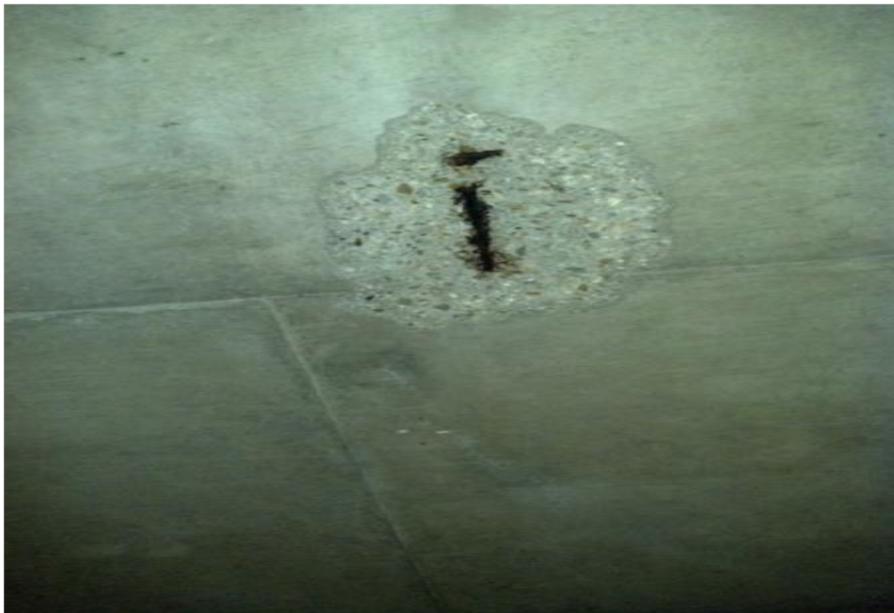
Photo 12: 12"x15" spall with exposed rebar on 2nd floor adjacent to column K-10, typical on floors 1-4

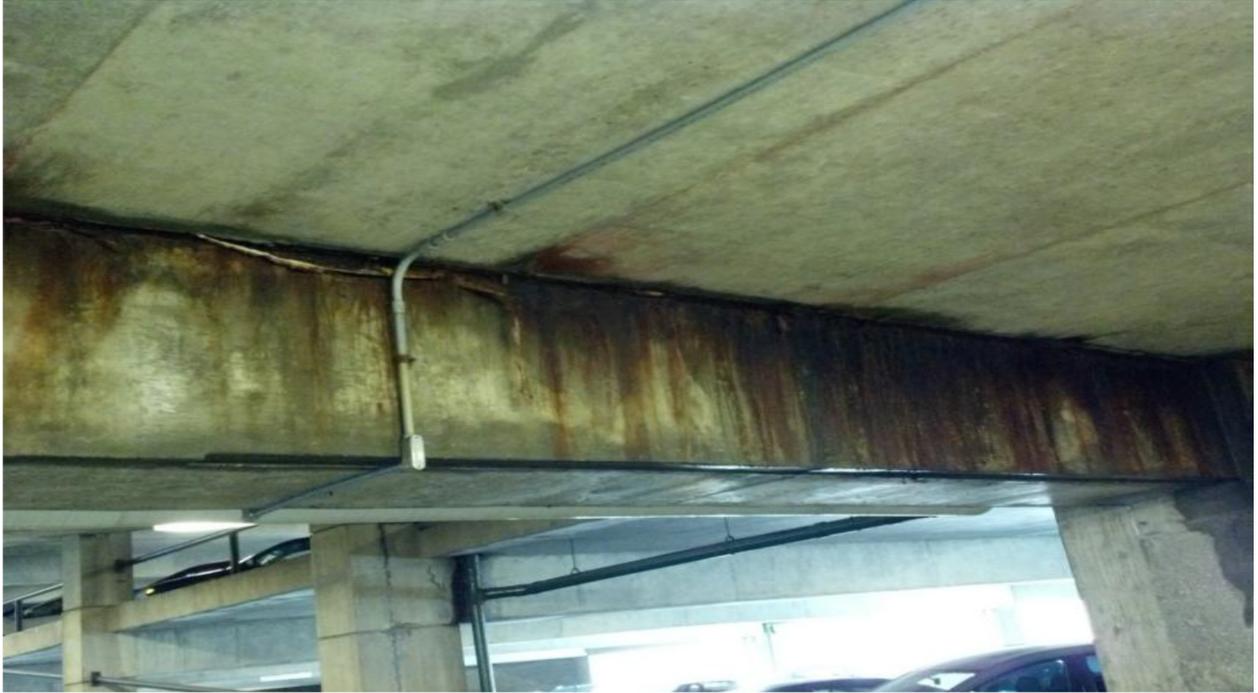
Photo 13: Failure of expansion joint and leaking at beam 10 on 2nd floor, typical all floors.

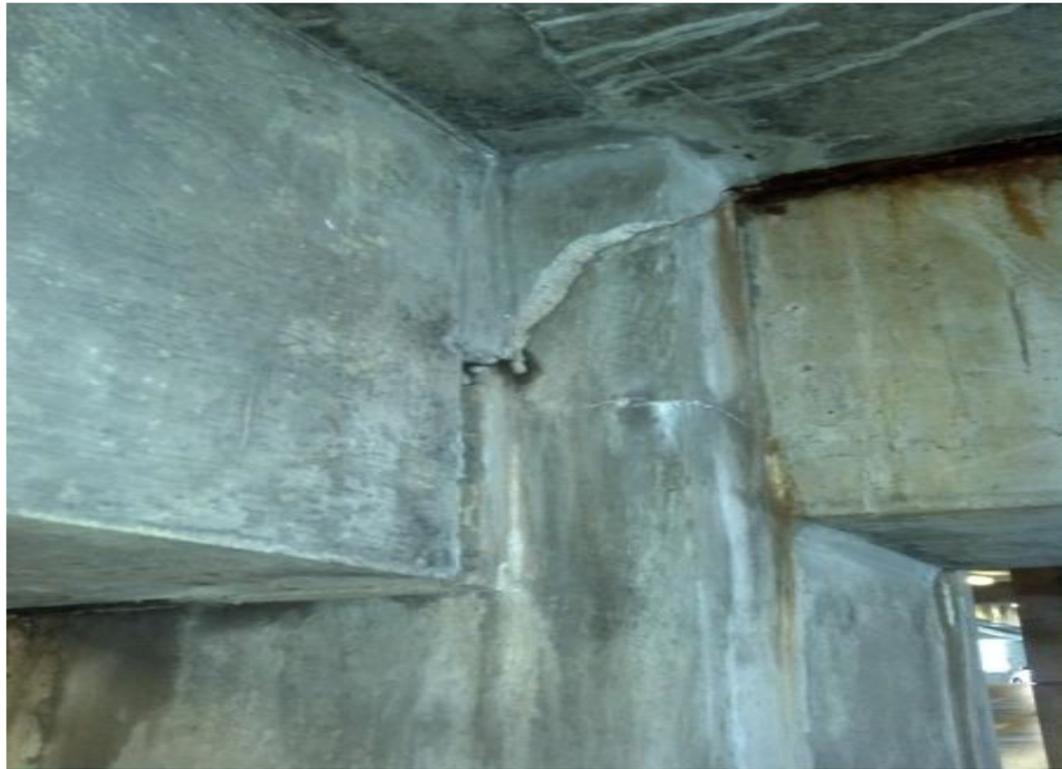
Photo 14: Half beam height x 1" W crack at beam support at column E-10, 2nd floor.

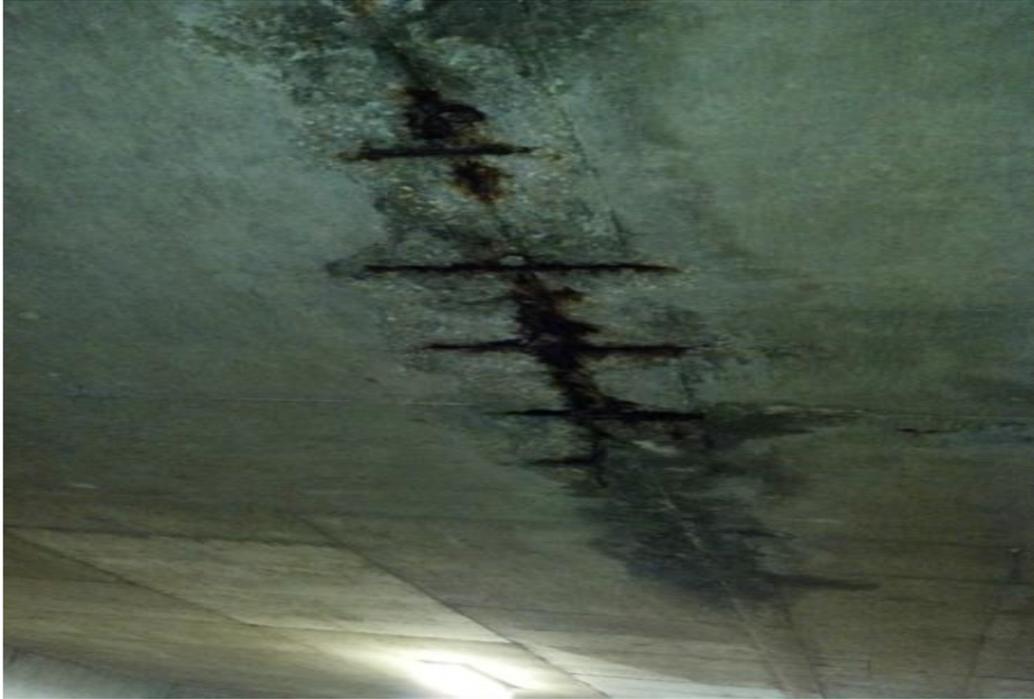
Photo 15: 18" W x ~10' L spall with exposed rebar in ceiling between columns K-5 and K-6, 3rdfloor.

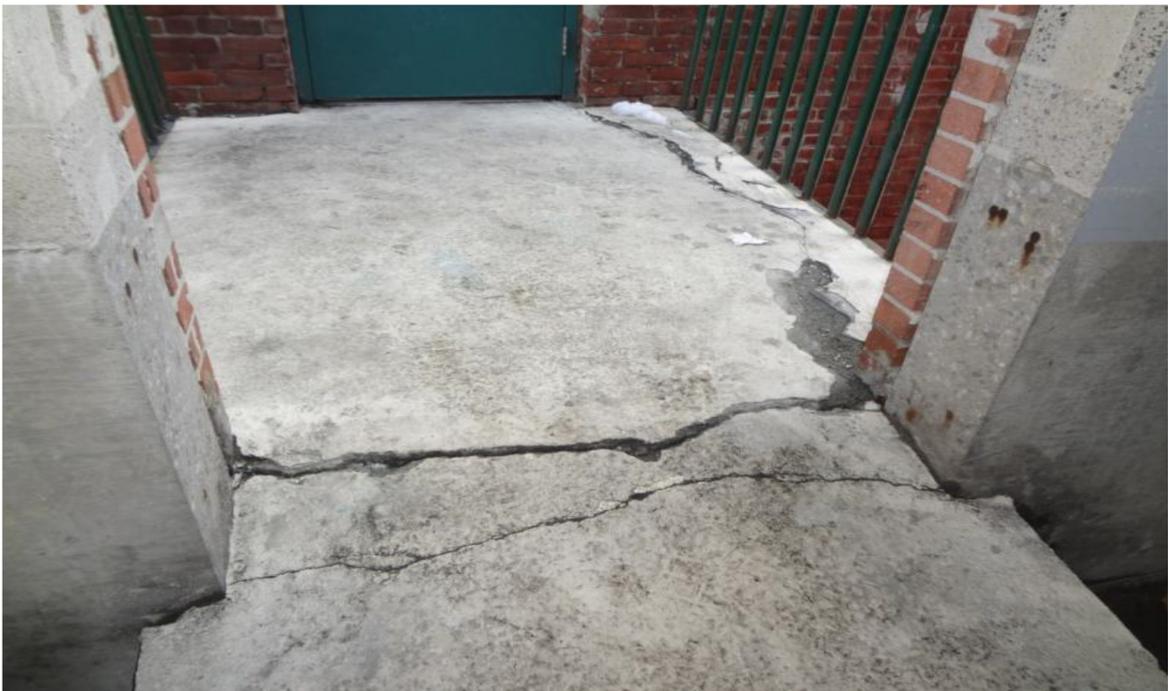
Photo 16: Full width by 1" cracking in 4th floor pedestrian foot bridge

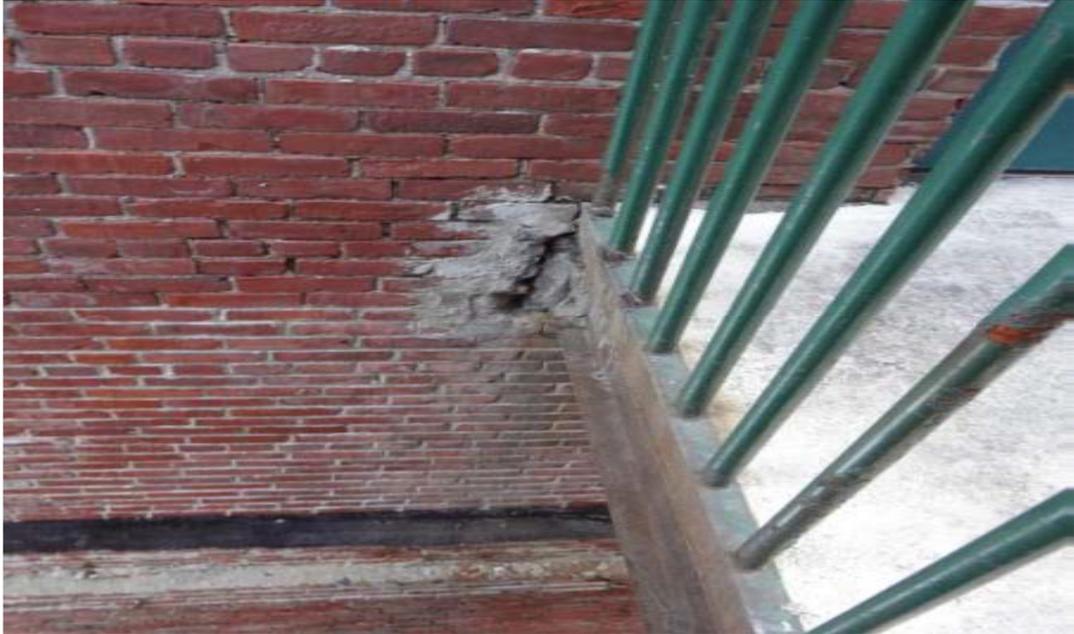
Photo 17: Deterioration of steel beam support connection on 4th floor pedestrian bridge

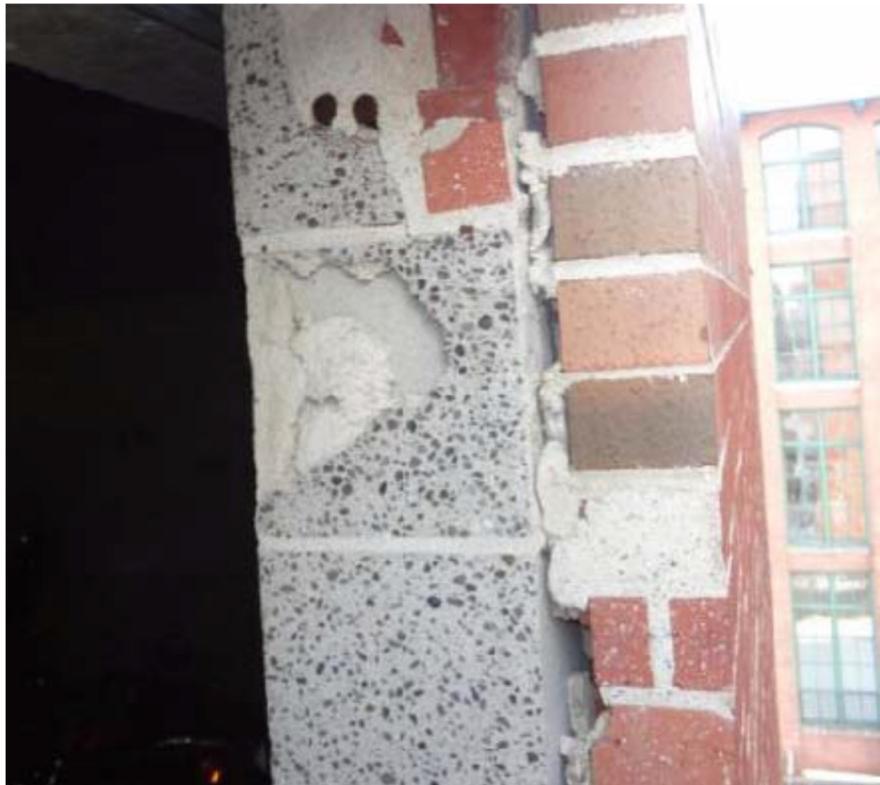
Photo 18: Incomplete connection of brick facing to concrete masonry blocks at 4th floor pedestrian bridge

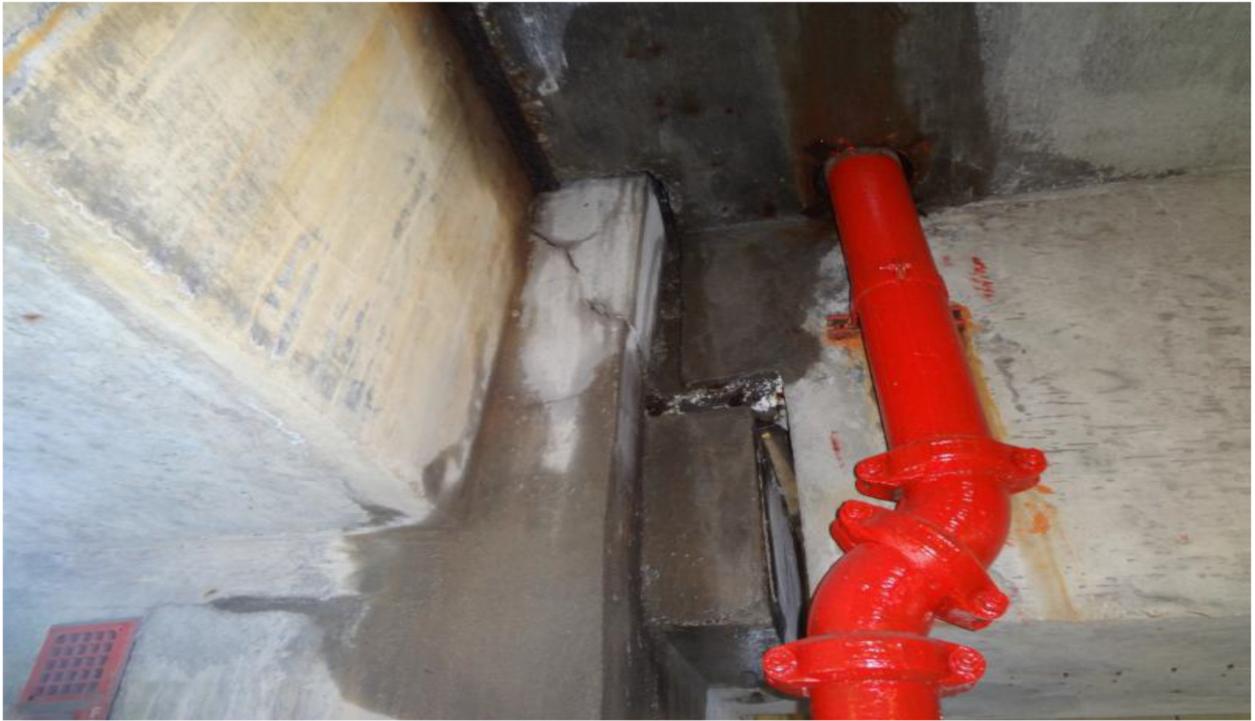
Photo 19: Cracking and spalling at beam support adjacent to leaking drain at column G-10, 4th floor.

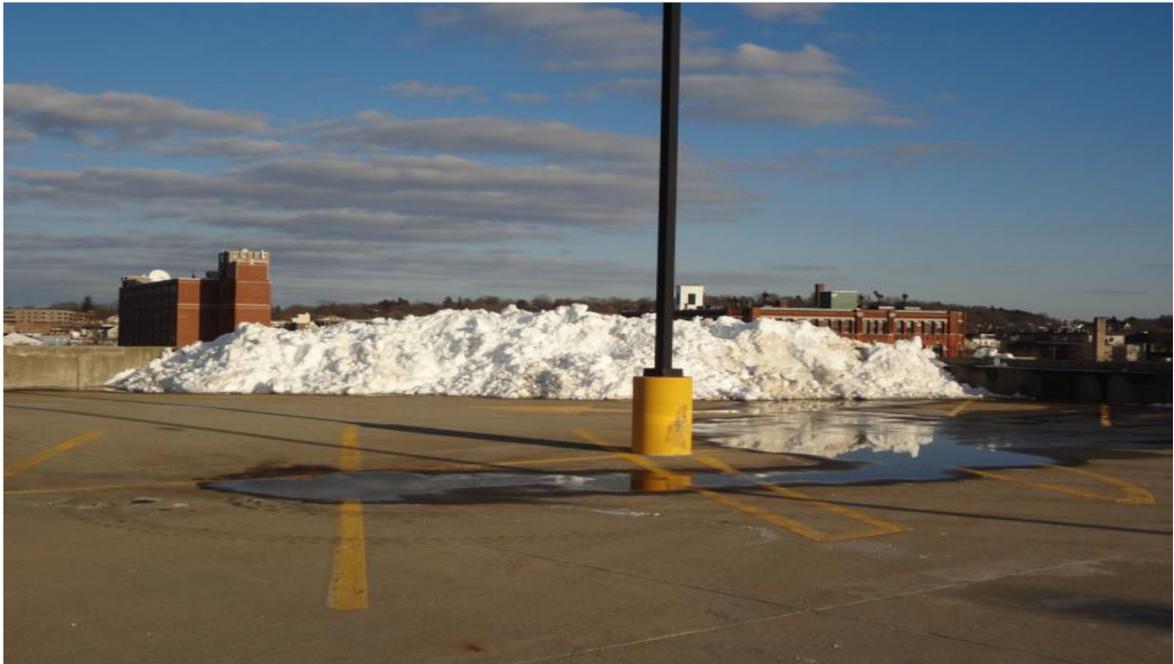
Photo 20: Melting snow stockpile on roof deck
